Non-Compliant Control Measures - 9/5/2018

Aerial photos of ACP construction obtained on 8/12/2018, 8/22/18, and 9/5/18 reveal a noncompliant runoff-control structure on a steep mountainside (>30% slope) to the north of Sand Fork in Lewis County. Water bars installed across the construction corridor were improperly built to convey runoff to a drainage ditch running straight down the mountainside. This structure was not compliant with erosion and sediment control requirements, and it was not depicted on construction plans approved by WV DEP and FERC.

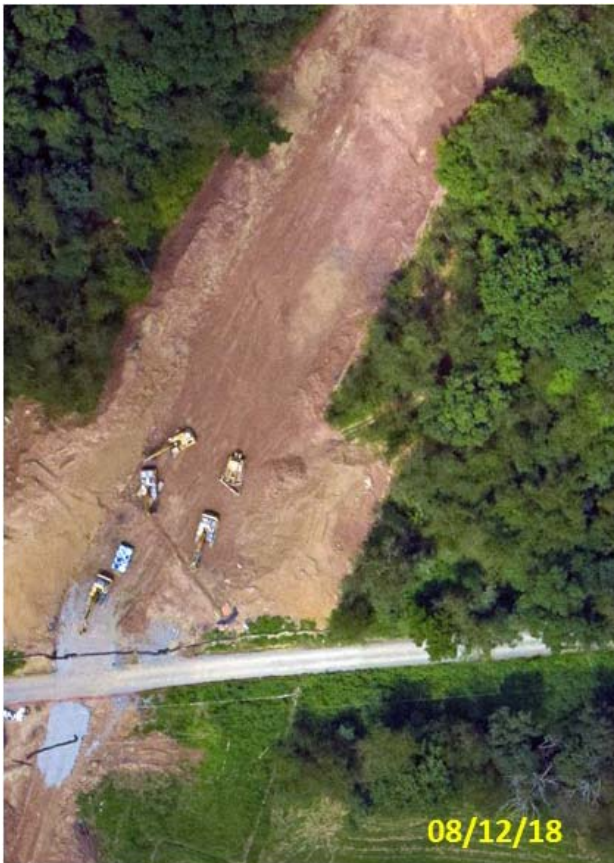
- [Aerial photo](#) showing the non-compliant drainage ditch.
- [Construction alignment sheet](#) for location in question.
- [Failing runoff control structure](#) at the downslope end of the drainage ditch.

A [Weekly Summary Report](#) (posted on 9/7/18) indicates that this location was inspected by FERC Compliance Monitors on 8/14/18 and 8/16/18. The summary noted the presence of a non-functioning slope breaker (water bar) and a failed silt fence. No reference was made to the noncompliant downslope runoff ditch evident in CSI's aerial photos.
